# Lay-Z-Spa™

## AIR AND HYDRO JET E02

All AirJet™ Spa's · All HydroJet™ Spa's  
**Troubleshooting Guide for all models 2017 & older**

### **E02 ERROR CODE**

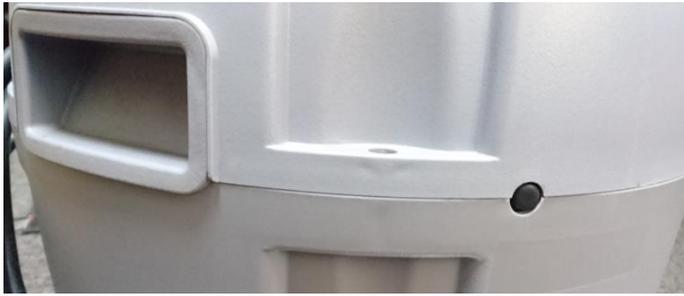
Reset Button on an Air Jet pump

Press thermal reset button (See picture for location of reset button on the final page)

On the PRCD (black box) press: Reset → Test → Reset.

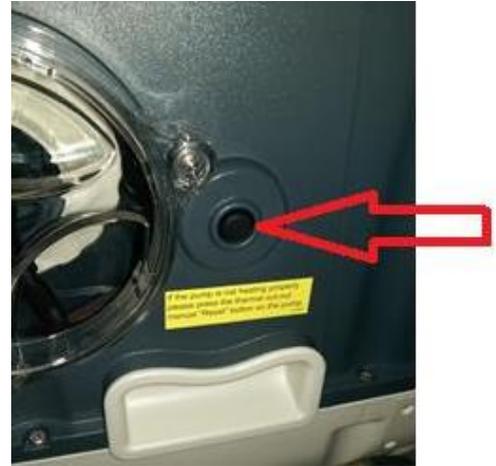
Reset Button on a Hydro Jet pump

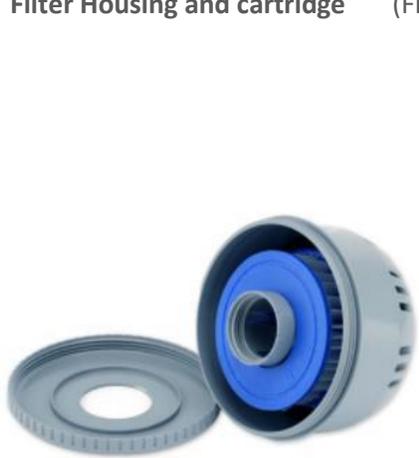
Filter Housing and cartridge (Fig.2)

During the use of the spa, the warmth of the water expands and contracts the filter housing plastic. If there is a small or invisible crack on the plastic housing, this can cause the E02 error code. However, there may be a blockage in this also which can cause the error code

Remove the complete filter housing from the inside of the liner (Fig.2)

If the E02 error code disappears for 2 to 3 hours, the issue is caused by the filter housing

This housing will be required to be replaced. If you are within your warranty period, please contact Bestway Aftersales Warranty. If you are outside of your warranty period, a replacement can be purchased from Bestway Store ([www.bestwaystore.co.uk](http://www.bestwaystore.co.uk))

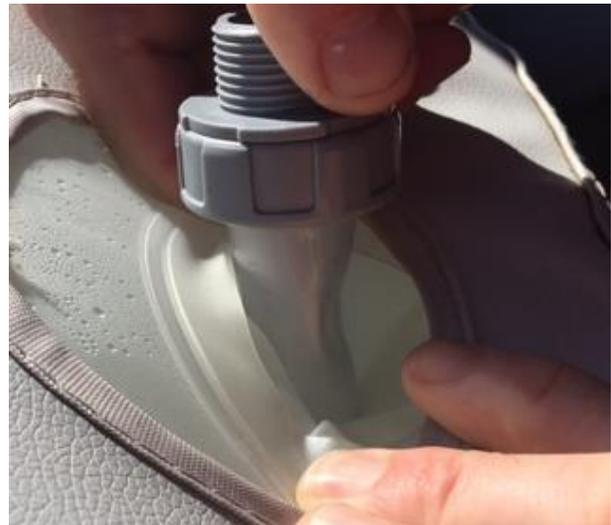
Bent or Kinked Pipes (Rig.3)

During the use of the spa, the warmth of the water can cause manipulation in the pipes of the liner

Also, during the packaging of the spa on initial purchase, there may be a small kink or bend in the liner pipes. These kinks can cause a restriction of the water flow through the liner to the pump

Using a torch or light from your phone/tablet, look through the pipe from the outside

If there is a small bend or kink, attempt to manipulate these out (Fig.3)

If you are unable to complete this, empty the spa water and air from the liner and use warm water to remove these

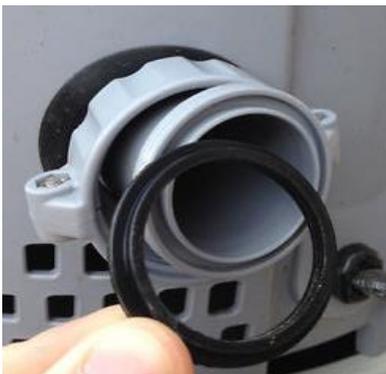
Perished Washers

During the use of the spa, the washers within the spa couplings may become perished or worn. These are within each of the coupling, A (largest), B and C

These couplings can be unscrewed using a small screw driver which will allow these washers to be checked (Fig.1)

If these washers are perished or worn, please contact Bestway Aftersales who will be able to provide further assistance
